From Installation to Preservation: An Inspection-Based Case Study of Drainage Vulnerability During Active Construction

Abstract

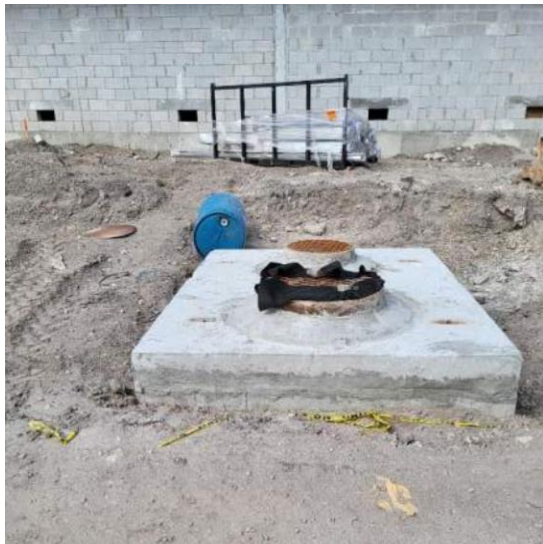
Fig. 1. Installed drainage well structure observed during the mid-construction stage, showing that stormwater infrastructure was already materially in place before final grading and site stabilization were completed.

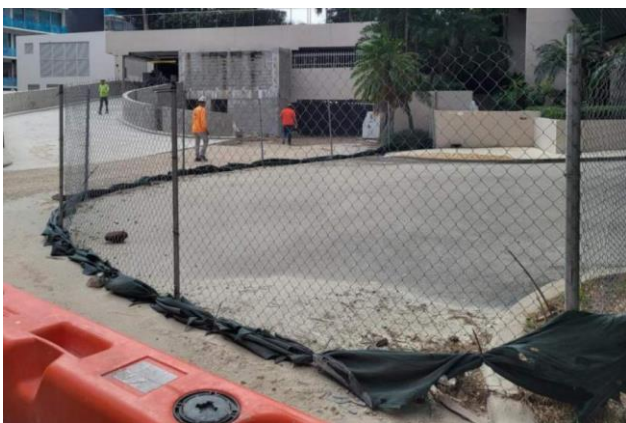
Fig. 2. Temporary sediment-control measures requiring maintenance, with sediment tracking visible outside the

intended construction zone. This condition indicates early weakening of the protective control environment around an already active drainage system.

The same site-scale logic also helps explain the earlier general maintenance condition from Report 1. That record identified erosion and dust-control maintenance needs, including sediment tracking outside the construction zone. A condition of that kind is not ordinarily corrected through one specialized engineered fix. It is corrected through renewed discipline in routine site-control measures: re-securing loose protective elements, restoring continuity at boundary controls, removing tracked material from travel paths, and re-establishing active maintenance of the disturbed work envelope. The later presence of more structured sediment-control measures around the work area is consistent with that broader corrective progression [4], [5], [11].

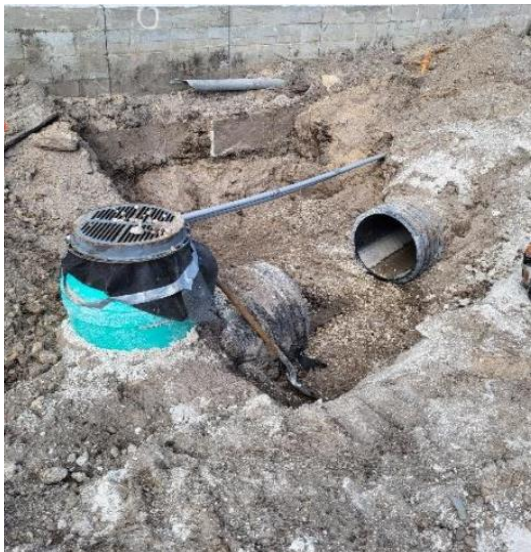
Fig. 3. Exposed Yard Drain 10 during lateral fitting work, showing a live drainage intake and connected piping temporarily left vulnerable to sediment intrusion.

This logic is clearly visible in the handling of Yard Drain 10. The original concern was that piping had been exposed during lateral fitting work and required protection against sediment intrusion. The later response documented that the fittings had been installed and the opening had been covered, with a photograph provided as confirmation. The significance of that sequence lies in its timing: the project did not deny the temporary exposure created by the work, but it did restore a barrier once the fitting operation advanced far enough to allow re-protection. In construction-control terms, that is an effective immediate response because it closes the direct sediment pathway before the exposed condition develops into deeper internal contamination [3], [13], [14].

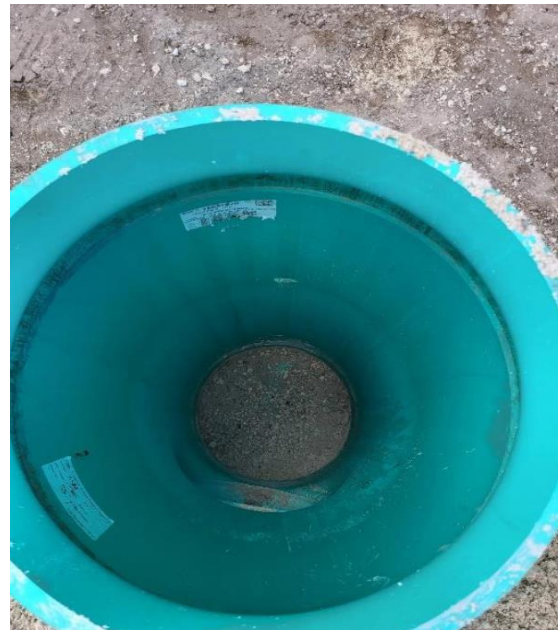
Fig. 4. Sediment observed inside Yard Drain 6, showing progression from exposure risk to actual intrusion at an active collection feature.

A similar response pattern appears at Yard Drain 6, though there the issue had already progressed beyond simple exposure. The report stated that the drain was unprotected, and that sediment had already been encountered inside it. The follow-up response nevertheless showed that the drain had been covered. That action mattered because once sediment has already entered a drain, the first obligation is still to stop additional entry. The corrective measure did not erase the earlier intrusion, but it did re-establish control at the intake point and prevent the drain from continuing to function as an open receiving point for more soil and debris [3], [13], [14].

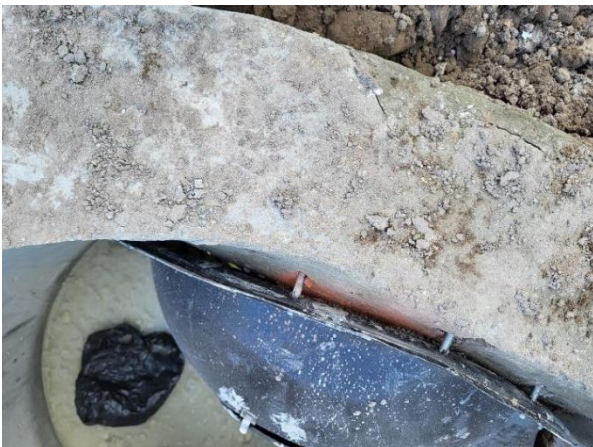
Fig. 5. Questioned baffle installation at MH-21, showing a vulnerable internal control detail with visible gap and questionable fastening condition.

The inspection record identified three distinct concerns at MH-21: the baffle was described as plastic rather than aluminum, it was not tight to the structure, and its anchorage was questioned. Each concern matters differently. A material difference raises the question of consistency with the approved design or accepted product path. A poor fit raises the risk of bypass around the edges rather than controlled interaction with the detail. Weak or uncertain anchorage raises the question of stability once the structure

The response path for MH-21 represents a different corrective category: detail correction combined with document reconciliation. The original observation was not that the structure lacked protection entirely, but that the internal pollution-control baffle did not conform to the expected condition. The issue involved material, fit, and anchorage at once. Because of that, closure could not be achieved by a simple cover-or-clean response. It required both technical correction in the field and alignment between the installed condition and the governing record.

The project's response proceeded in layers. First, the field-side issue was acknowledged as an active correction item, with the subcontractor stating that the installation would be tightened. That mattered because the fit and stability concerns affected whether the baffle could actually function

as intended within the manhole. At the same time, the project identified that the governing note needed to be reconciled with the accepted substitution path for the plastic baffle. This second step is what makes the response analytically important. The project did not treat the matter only as a workmanship issue. It recognized that field acceptability and document accuracy both had to be addressed.

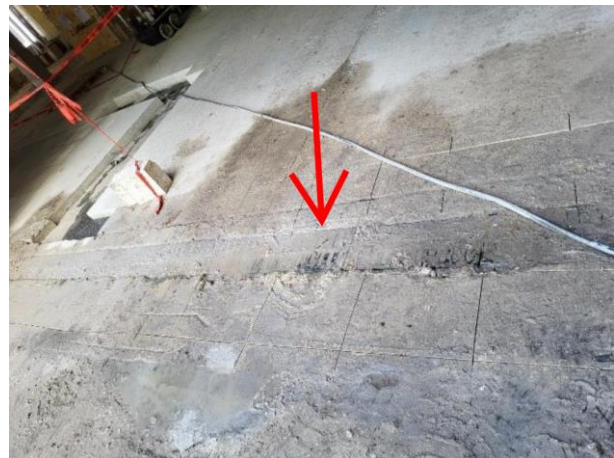
Fig. 6. Sediment-filled trench drain at the existing driveway interface, illustrating localized loss of drainage collection capacity during active construction.

That is why the reported driveway condition is more serious than ordinary dirt buildup. A trench drain filled with sediment is no longer functioning merely at reduced neatness. It is functioning at reduced hydraulic effectiveness. In plain language, water loses part of the path that was supposed to carry it away. For a technical reader, the problem is one of diminished inlet efficiency and reduced conveyance capacity caused by sediment occupying the collection zone. For a broader reader, the meaning is simple: the drain cannot take in and move water properly if soil is already occupying the space meant for water [13], [14].

A different but still coherent response appears in the handling of the sediment-filled trench drain at the existing driveway. There, the project response indicated that the trench drain was an existing one and would be removed. That shifted the logic from in-place restoration of a permanent feature to managed disposition of an existing interface that was not intended to remain part of the final stabilized system. In other words, the project did not treat that condition as requiring long-term preservation of the existing element. It treated it as a field condition whose proper resolution lay in removal as the work advanced. This is still a legitimate closure path because it answered the observed impairment by clarifying that the affected element would not remain a relied-upon drainage component in the final configuration.

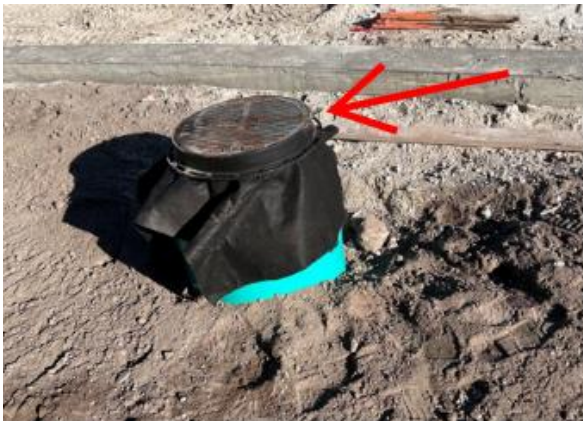
Fig. 7. Reinstated temporary covering at Yard Drain 6 after the reported deficiency, showing immediate field protection used to interrupt further sediment entry into an active drainage feature.
